2016 Road Survey Report

During our 2016 citizen science surveys of road and culvert conditions in the Gifford Pinchot National Forest, we collected data on over 22 miles of roads and 157 culverts in the Trout Creek watershed and Iron Crystal Planning Area. The collection of this valuable information and the restoration initiatives that are planned as a result would not be possible without the hard work of our dedicated volunteers. This report aims to briefly outline the findings and recommendations. It includes summary information, detailed maps, and tables of the collected field data, all of which highlight the information that is to be used for stream restoration and roads planning.

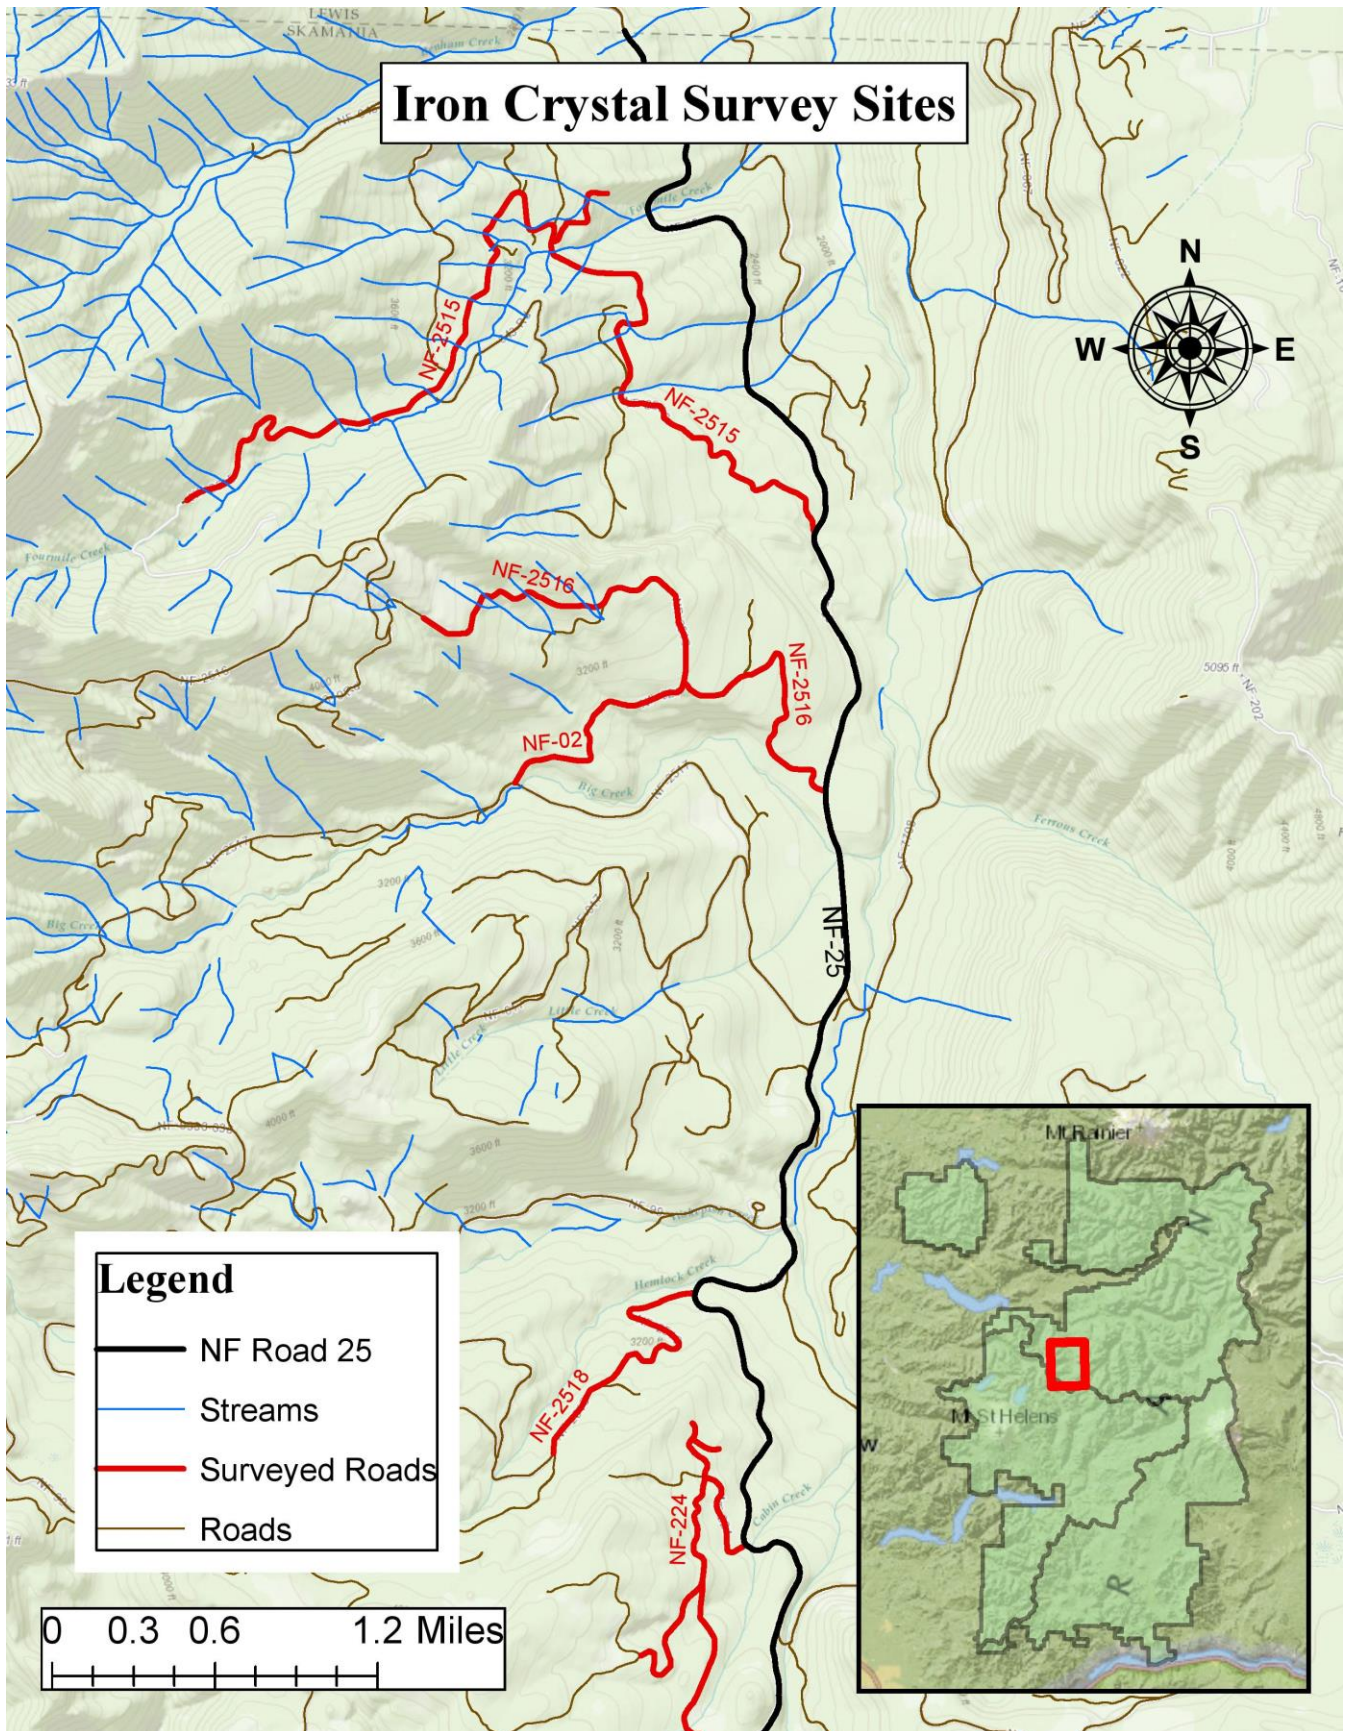
NF-2515 Culvert Survey

NF-2515: Largely within a Riparian Reserve, this road has numerous areas in need of restoration. About 1.5 miles from where the NF-2515 meets the NF-25 there is a bend in the road that has two culverts that are completely plugged. These blocked culverts are contributing to the severe erosion on the road. Restoration on culverts [141](#) & [146](#) is strongly recommended. Road 2515 closely follows Fourmile Creek along almost its entire stretch. Current fish presence in Fourmile Creek is not known, but this creek and several other creeks that are crossed by 2515 flow into Iron Creek to the east, which is home to coho and steelhead. Restoration along 2515 would benefit aquatic species in Fourmile Creek as well as coho and steelhead living in Iron Creek. Bentham Creek, which lies 0.5 miles to the north of the road and approximately 300 feet away from several roads that branch off from 2515, contains populations of cutthroat trout. This road crosses through the middle of a northern spotted owl circle, a species that benefits from relatively low road densities. With the hydrological issues found along this road and the species that would benefit from restoration efforts, we recommend replacing the culverts that are not functioning yet occurring along needed road segments and closing the road segments that are less needed yet impacting wildlife and fish populations.
