2016 Road Survey Report

During our 2016 citizen science surveys of road and culvert conditions in the Gifford Pinchot National Forest, we collected data on over 22 miles of roads and 157 culverts in the Trout Creek watershed and Iron Crystal Planning Area. The collection of this valuable information and the restoration initiatives that are planned as a result would not be possible without the hard work of our dedicated volunteers. This report aims to briefly outline the findings and recommendations. It includes summary information, detailed maps, and tables of the collected field data, all of which highlight the information that is to be used for stream restoration and roads planning.

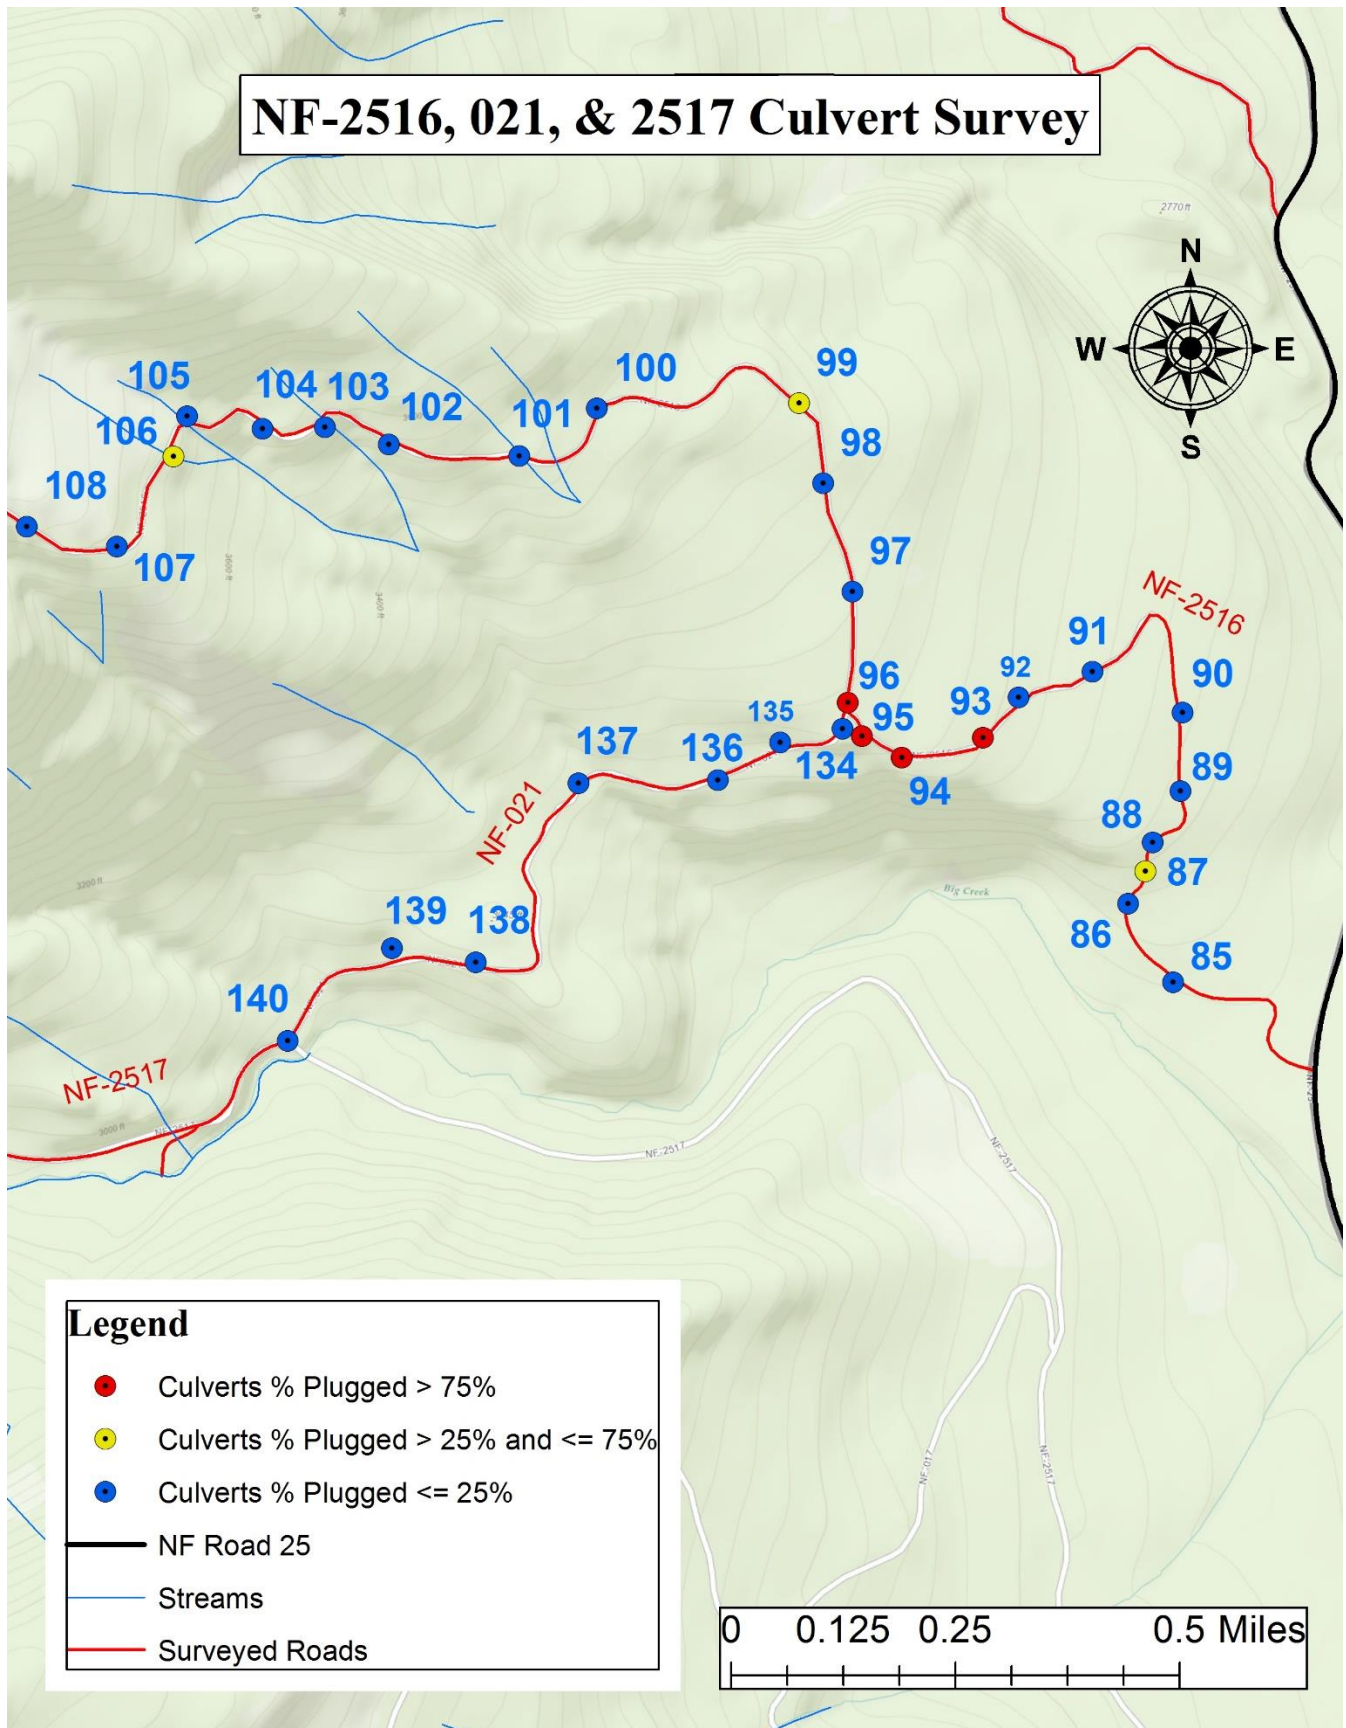
NF-2516, 021, & 2517 Culvert Survey

NF-2516: This road has at least four blocked culverts ([93](#),[94](#),[95](#),[96](#)) where the NF-021 and NF-2516 meet; these blocked culverts are contributing to the significant amount of erosion observed along this road. Two large collections of trash warrant an initial cleanup visit. The views along this road are truly spectacular, and the landscape is a unique mix of silver fir forest and rolling hills of native grasses. We feel this area should be protected and that the management units along its stretch be removed from consideration for logging. Moreover, this area is a prime candidate for expanding recreational opportunities with new hiking trails that can connect to the trails and recreation areas (near Mount St. Helens) on the western side of Strawberry Peak. This would align with Land Resources Management Plan (LRMP) objectives and would help support

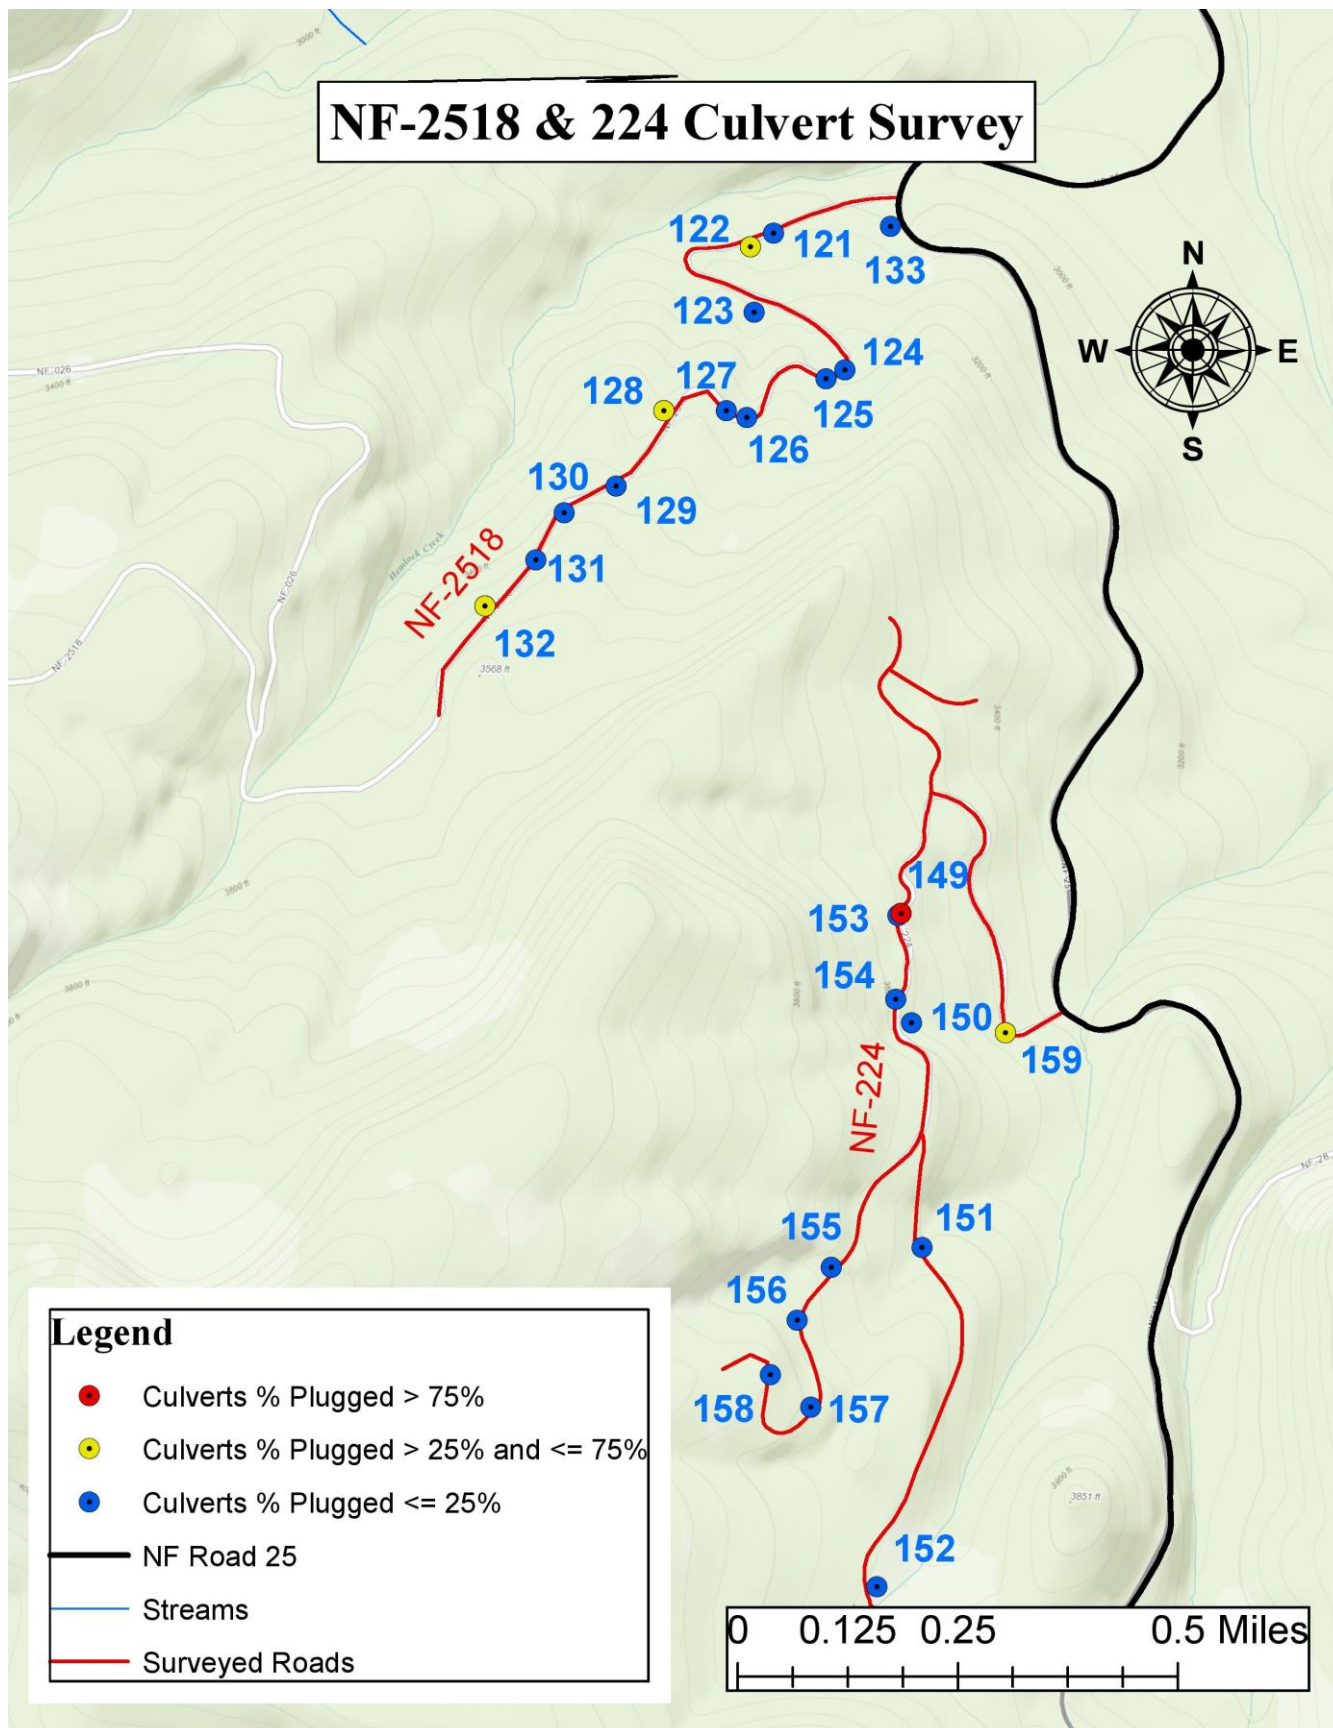
NF-2518 & 224 Culvert Survey

NF-224: One blocked culvert (149) were found along NF-224. Several fallen trees and poor road maintenance limit vehicle movement along this road. Priority road for maintenance and repair.

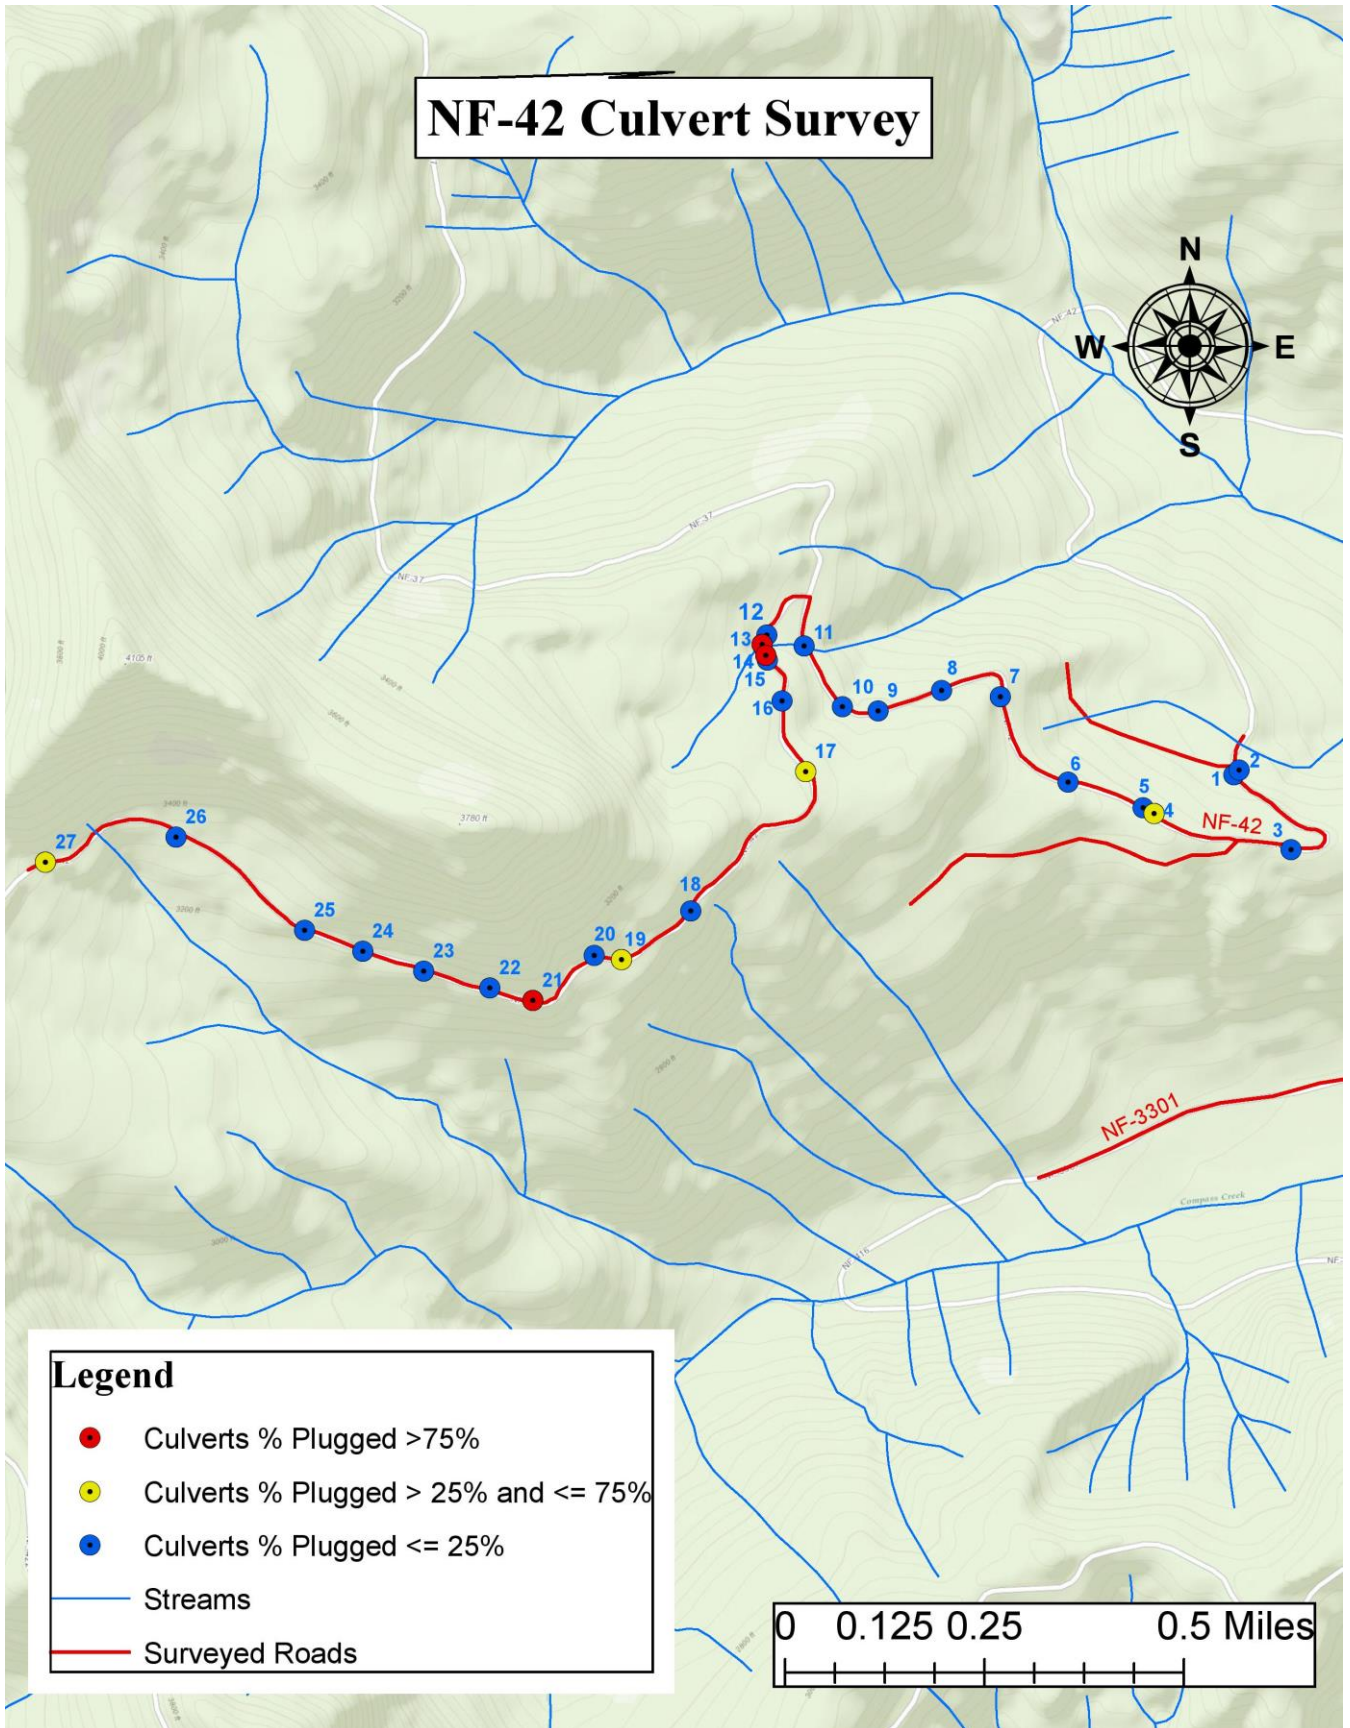
NF-42 Notes

NF-42: Blocked culverts were found in three locations (13,14,21). Fallen trees, erosion, and encroaching vegetation all obstruct this road. Heavy impact from firewood collection was observed, however it appears to be within planned firewood harvest areas (12). NF-42 parallels streams with steelhead. This road is an important access road so should be considered as a priority road for repair and maintenance to support access and decreases impacts to fish and aquatic systems.

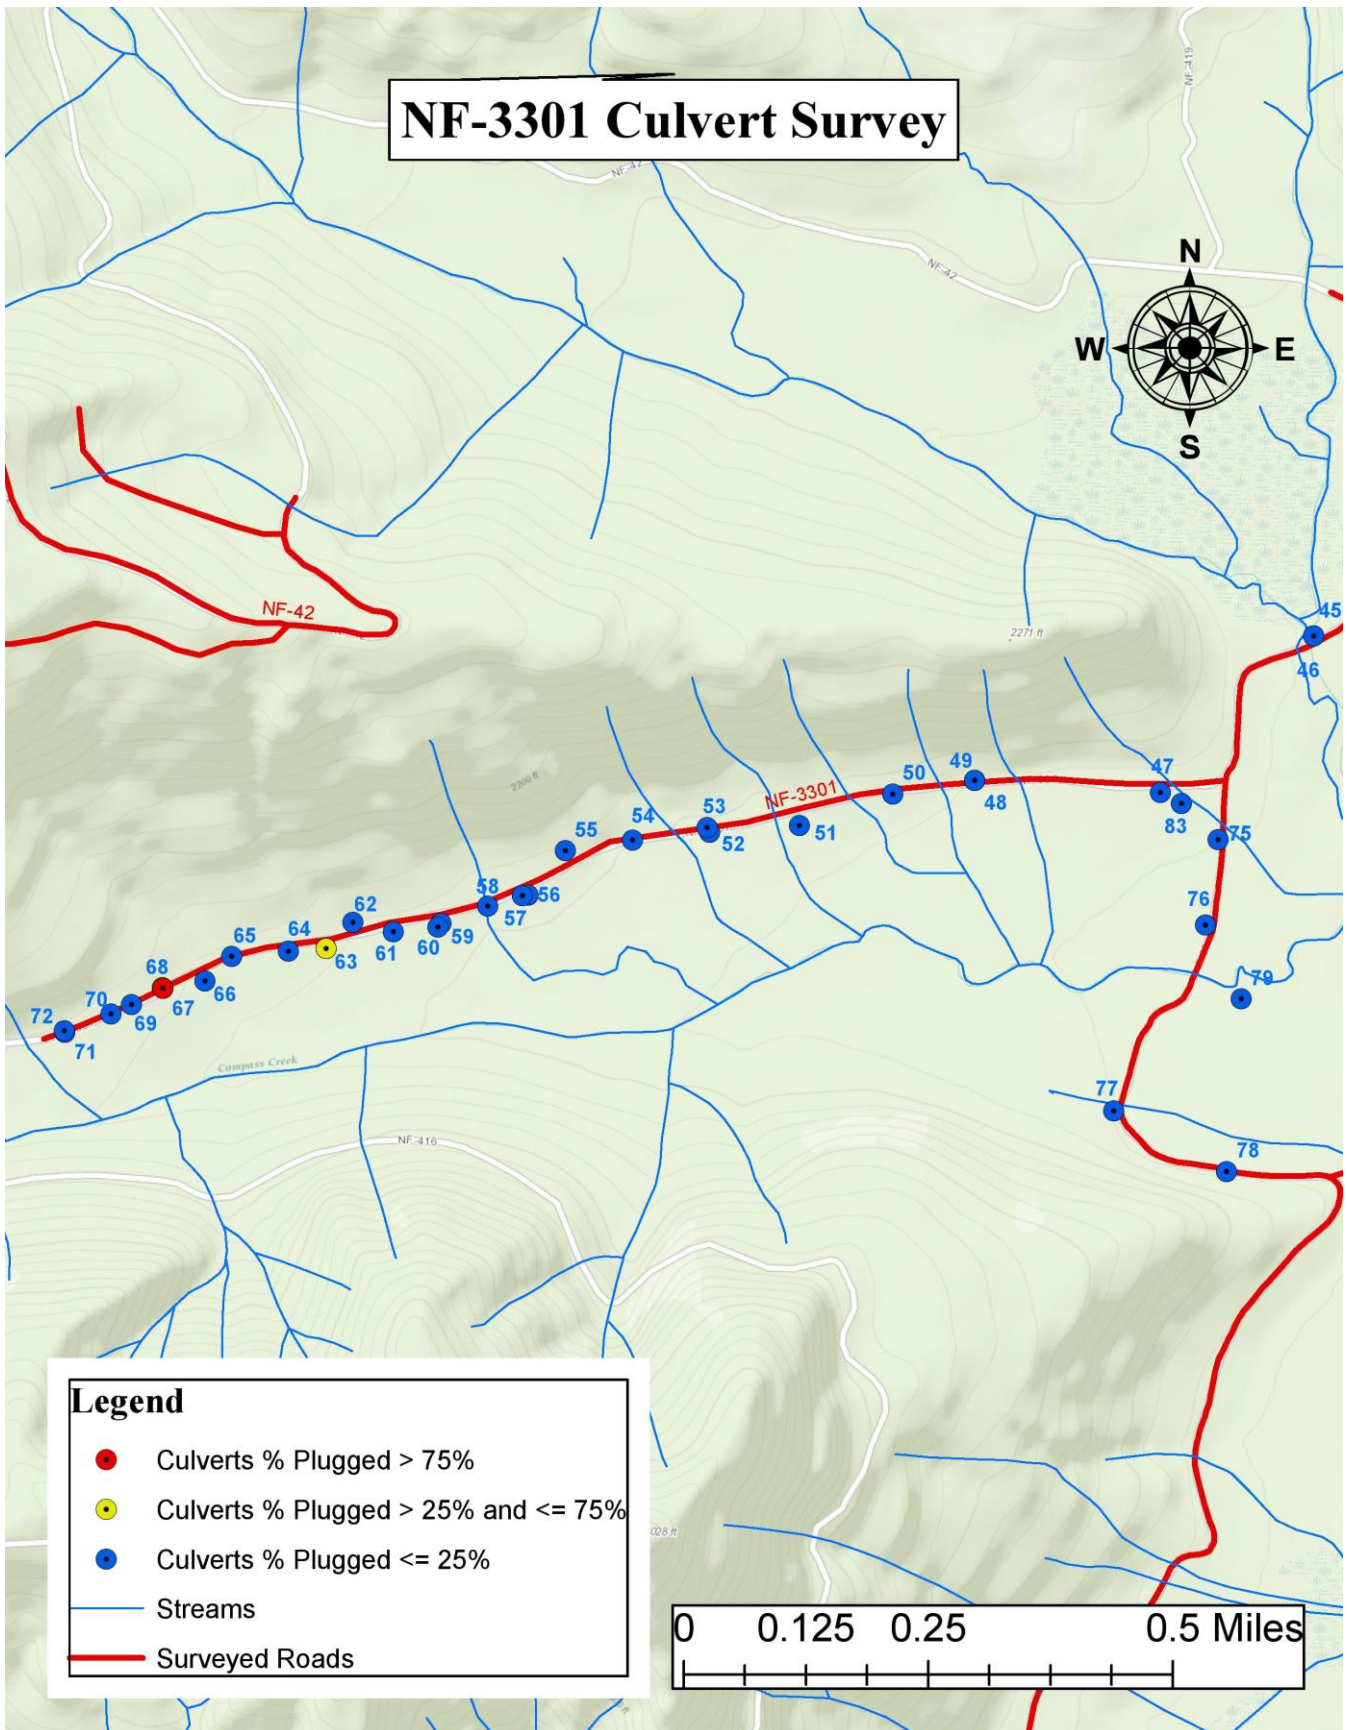
NF-3301 Notes

NF-3301: Except for one plugged culvert (68) along this stretch of road, culverts are in good condition. There are, though, several areas with excessive amounts of trash (42,43,48) and a small patch of scotch broom (54). There is also evidence of a closed road being regularly used (49). Since this road contains many stream crossings and parallels Compass Creek, home to a population of steelhead, it should be regularly monitored for blocked culverts and other watershed impacts.

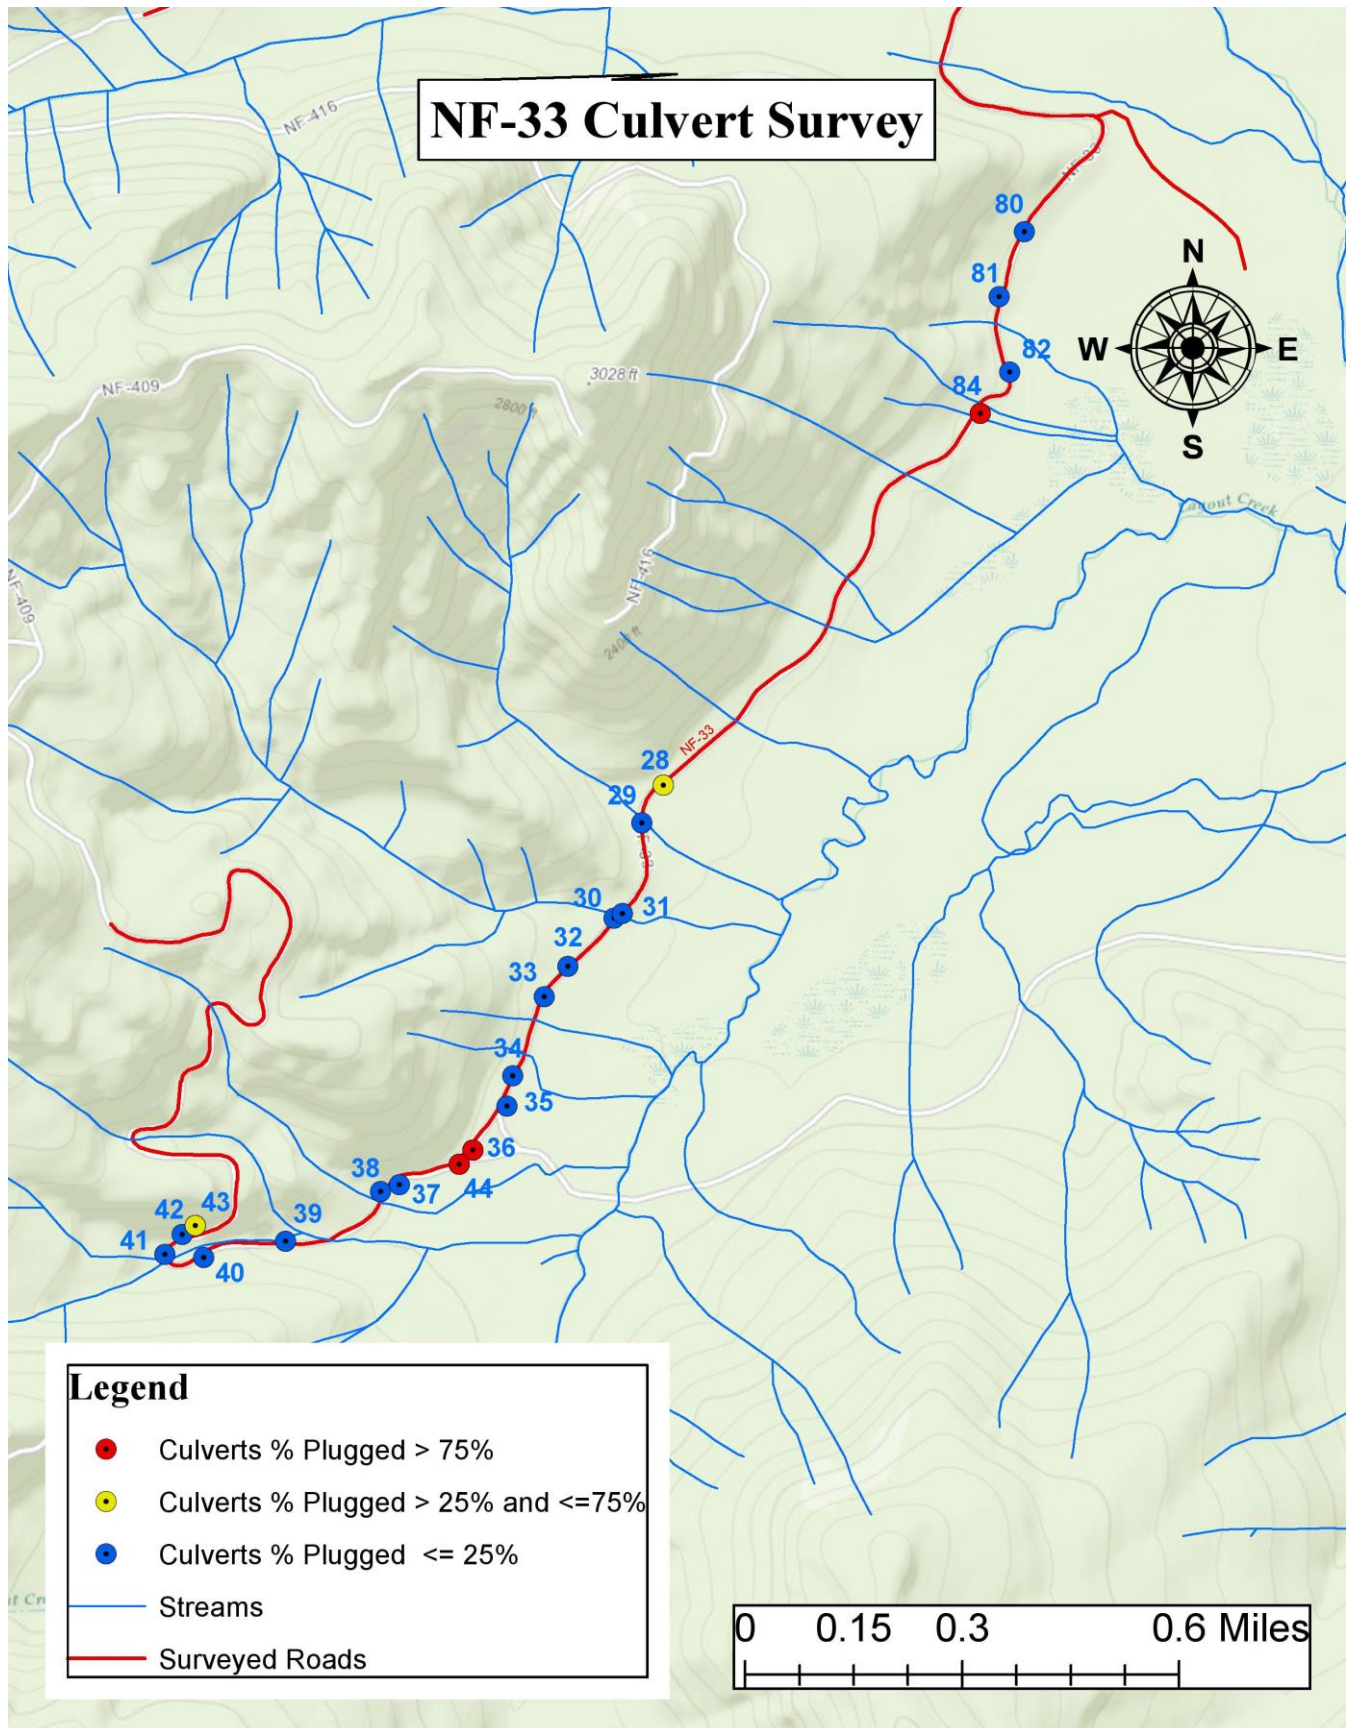
NF-33 Culvert Survey

NF-33: There is evidence of two different beargrass harvesting sites (33 & 39) and related trash and disturbance. There are several road obstacles and significant erosion obstructing this road. Three blocked culverts (36,44,84) were found along the stretches we surveyed. This is an important access road and should be a priority for repair and continued maintenance. NF-33 crosses Compass Creek (where a large floodplain exists and which serves as habitat for steelhead), parallels Layout Creek (one of the other local creeks that are home to steelhead), and crosses an unnamed creek (with rainbow trout).
