CASCADE FOREST

# 2017 Road Survey Report

During our 2017 citizen science surveys of road and culvert conditions in the Gifford Pinchot National Forest, we collected data on over 13 miles of roads and 31 culverts in the Panther Creek and Trapper Creek-Wind River watersheds. This report aims to outline the findings and recommendations from these surveys. It includes summary information, detailed maps, and tables of the collected field data, all of which highlight information that is intended to be used for stream restoration and roads planning. This on-the-ground information and the restoration initiatives that can be planned from it would not be possible without the hard work of our dedicated volunteers.

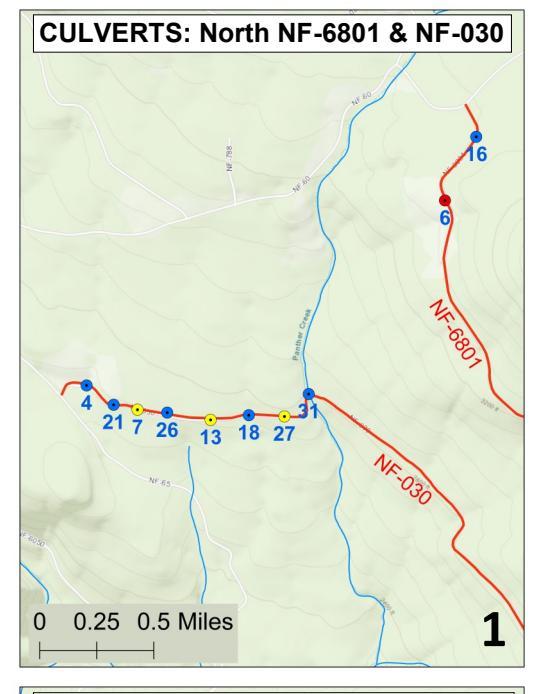
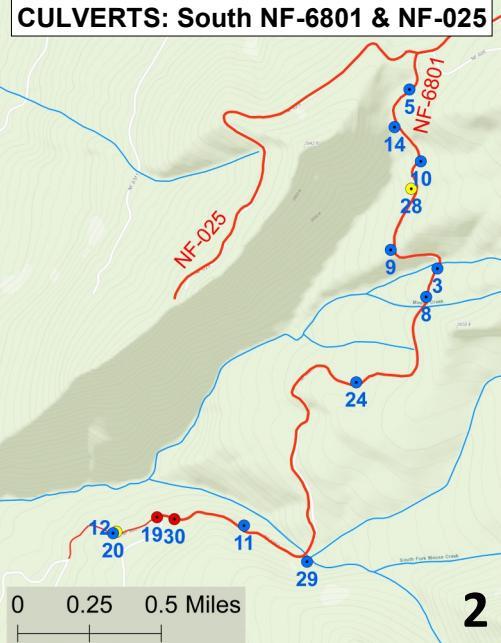
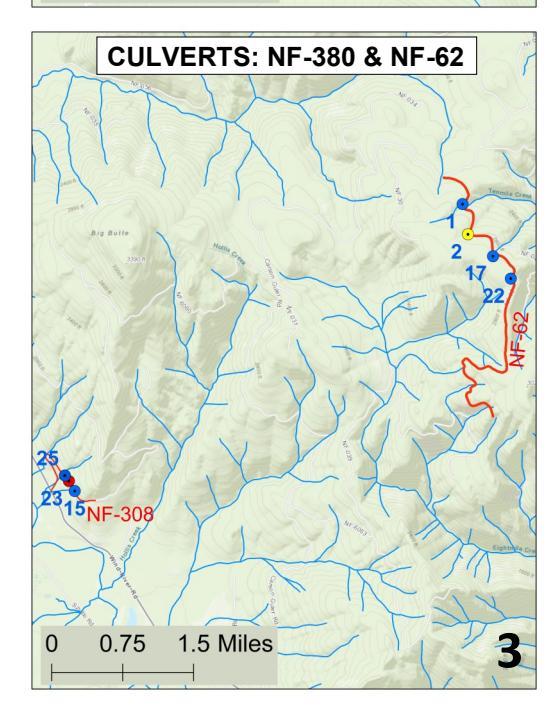
#### Appendix A: CULVERTS

We encountered three culverts with *outlets* that were 100% plugged, two that were 75% plugged, and one that was 50% plugged (percentages were rounded up or down to the nearest quarter). We encountered two culverts with *inlets* that were 100% plugged, two 75% plugged, and five that were 50% plugged. Object IDs listed below can be referenced in the associated maps to identify where each of these culverts are located, and therefore, to prioritize the areas most in need of restoration.

Object ID	Culvert Diameter	Depth to Inlet	Depth to Outlet	% of Inlet Plugged	% of Outlet Plugged	Width of Road	Road Grade	Notes
1	18"	10"	12"	-	25%	0'	-	4 ft from bottom of culvert to stream bed
2	16"	30"	120"	50%	50%	8'	Up	
3	48"	120"	94"	0%	0%	10'	Up	
4	16"	42"	36"	25%	25%	9'	Up	
5	16"	20"	48"	0%	0%	8'	Up	
6	12"	24"	48"	100%	100%	11'	Dow n	
7	24"	24"	36"	50%	0%	11'	Flat	Inlet mashed some
8	Other	360"	0"	0%	-	0'	Up	Culvert 6 feet diameter
9	24"	12"	36"	25%	25%	10'	Up	Possible new culvert, has some vegetation 1.5 in. away. Manmade trail, not recently used. Cut logs 75 ft. into & across the trail
10	18"	96"	144"	0%	0%	10'	Up	
11	24"	12"	40"	25%	0%	11'	Up	
12	Other	24"	60"	25%	75%	0'	Dow n	
13	18"	24"	24"	50%	75%	9'	Up	Short grasses in center of road
14	16"	12"	120"	0%	0%	10'	Up	
15	24"	5"	0"	0%	0%	0'	Up	
16	12"	36"	48"	0%	0%	14'	-	
17	16"	24"	60"	0%	0%	80'	Up	Washed out below culvert outlet
18	18"	52"	8"	25%	25%	9'	Up	Somewhat dented

19	Other	12"	0"	75%	100%	0'	Up	Crosses under side road
20	18"	30"	72"	25%	0%	11'	-	
21	16"	24"	36"	25%	0%	9'	Up	
22	12"	48"	180"	0%	-	8'	Up	3 ft drop from end of culvert
23	18"	54"	0"	75%	100%	0'	Up	
24	18"	30"	36"	0%	25%	13'	Up	
25	24"	36"	0"	0%	0%	60'	Up	
26	18"	18"	36"	25%	0%	9'	Flat	Culvert depth was really 20, 7 in. from bottom of culvert to ground
27	18"	24"	24"	50%	25%	8'	Dow n	
28	24"	80"	240"	50%	0%	9'	Up	Outlet has log on it, significant erosion around.
29	Other	72"	100"	0%	0%	10'	Up	Stream culvert
30	18"	24"	60	100%	25%	10'	Up	
31	Other	-	0"	-	-	-	-	Large culvert about 10 feet down. Too steep to get down.

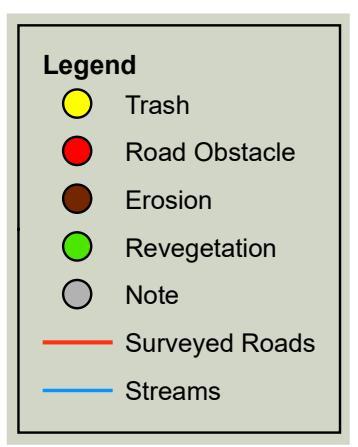
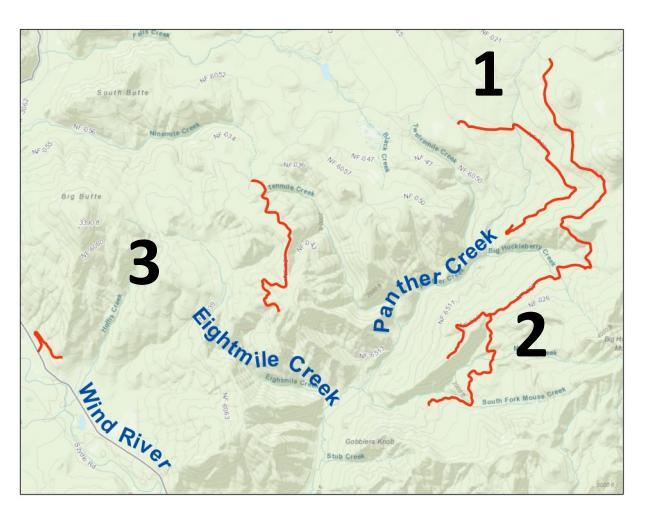
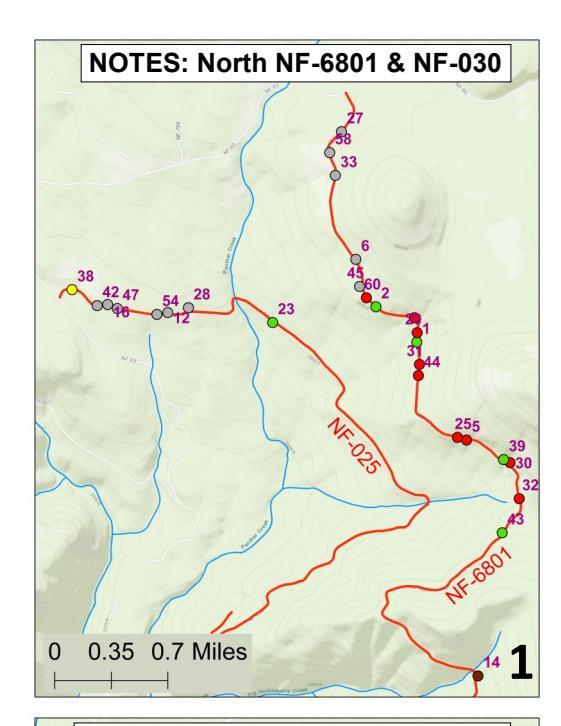
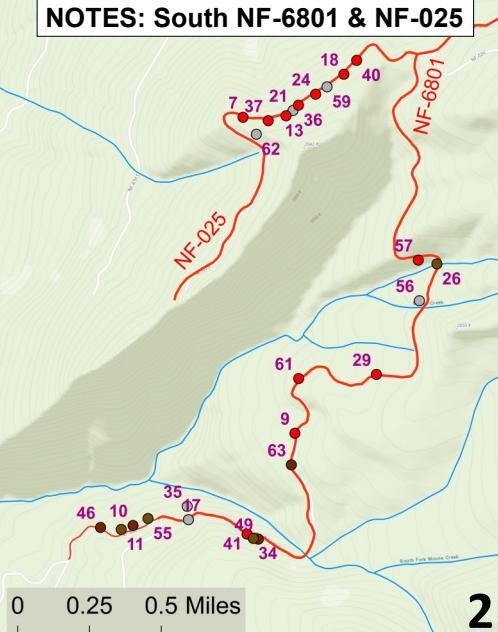
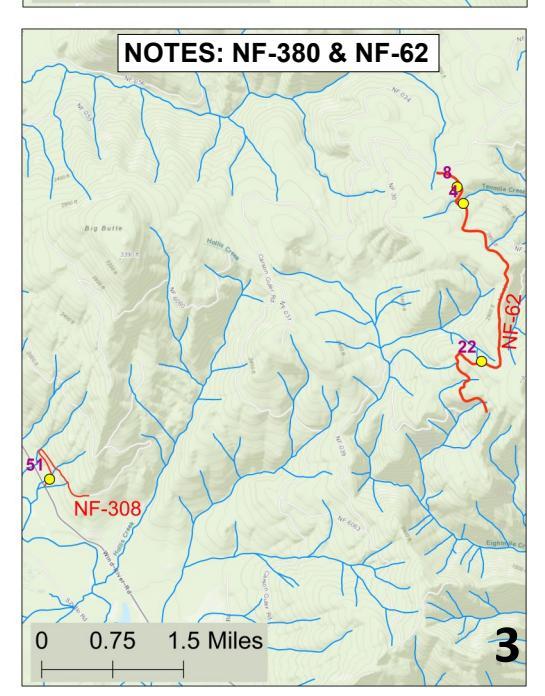
#### **Appendix B: NOTES**

Object ID	Observation	Notes				
1	Revegetation	Middle of road and right side of road				
2	Revegetation	Over roadway				
3	Survey Stop					
4	Trash	Stove and toilet over the bank				
5	Road Obstacle	Young tree				
6	Note	Pine leaning over left side				
7	Road Obstacle					
8	Trash	Board on right shoulder used for target practice				
9	Road Obstacle					
10	Erosion	Mild erosion				
11	Erosion	Mild erosion				
12	Note	Diverse multi story partially open canopy stand with wide trees				
13	Road Obstacle					
14	Erosion	Washout severe 2/5 width				
15	Survey Start					
16	Note	Dispersed campsite with old fire ring				
17	Note	Running water hole approx 6 ft from road. Couldn't find an				
10	Deed Obstaals	outlet of a pipe in the noie so couldn't commit as a cuivert				
18	Road Obstacle					
19	Road Obstacle	Deedwideen				
20	Road Obstacle	Rodu Widelis				
21	Trach	48 DBH tree on left of road, outside edge of unit

22	IIdSII					
23	Revegetation	More grass in center of road, stopped road monitoring especially culverts				
24	Road Obstacle					
25	Road Obstacle	Large pothole				
26	Erosion	Medium erosion				
27	Note	Rotted tree protruding over right side of road. Small pine tree leaning into road right side.				
28	Note	Dispersed campsite with fire ring				
29	Road Obstacle					
30	Road Obstacle	Tree down over left side of road				
31	Road Obstacle					
32	Road Obstacle	Large half tree blocking half road. Young tree leaning to middle of road				
33	Note	Young alder tree left side encroaching road				
34	Erosion	Mild erosion				
35	Note	Water running under road but no visible culvert				
36	Road Obstacle					
37	Road Obstacle					
38	Trash	Area at the beginning of the road was full of garbage				
Table continued on next page

Object ID	Observation	Notes				
39	Revegetation	Trees growing in middle				
40	Road Obstacle					
41	Road Obstacle					
42	Note	Tree on south side of road 101 cm DBH edge of proposed tim- ber sale.				
43	Revegetation	Middle and sides of road				
44	Road Obstacle					
45	Note	Campsite on left side. Garbage and gun shells. Picked some up.				
46	Erosion	Severe washout full width road				
47	Note	Large tree in proposed cutting area 81 cm DBH				
48	Survey Start					
49	Erosion	Mild erosion				
50	Road End	Berm and tank trap close road beyond this point, road naturally closing, road has been decommissioned				
51	Trash					
52	Survey Stop					
53	Survey Stop					
54	Note	103 cm DBH, large 81 cm DBH, tree 99 cm DBH trees on edge of timber sale				
55	Erosion	Very mild erosion up this entire stretch of road.				
56	Note	Potholes shallow				
57	Road Obstacle					
58	Note	Weeds growth center of road and encroaching on left shoulder.

59	Note	Dense young forest				
60	Road Obstacle					
61	Road Obstacle					
62	Note	Open well-spaced healthy forest				
63	Erosion	Mild erosion
